STUDY OF PIPING FAILURES
AND EROSION DAMAGE FROM RAIN IN
CLAY DAMS IN OKLAHOMA AND MISSISSIPPI

JAMES L. SHERARD
Consulting Engineer
March 1972

Report Prepared for
U. S. Department of Agriculture
Soil Conservation Service

March 15, 1972

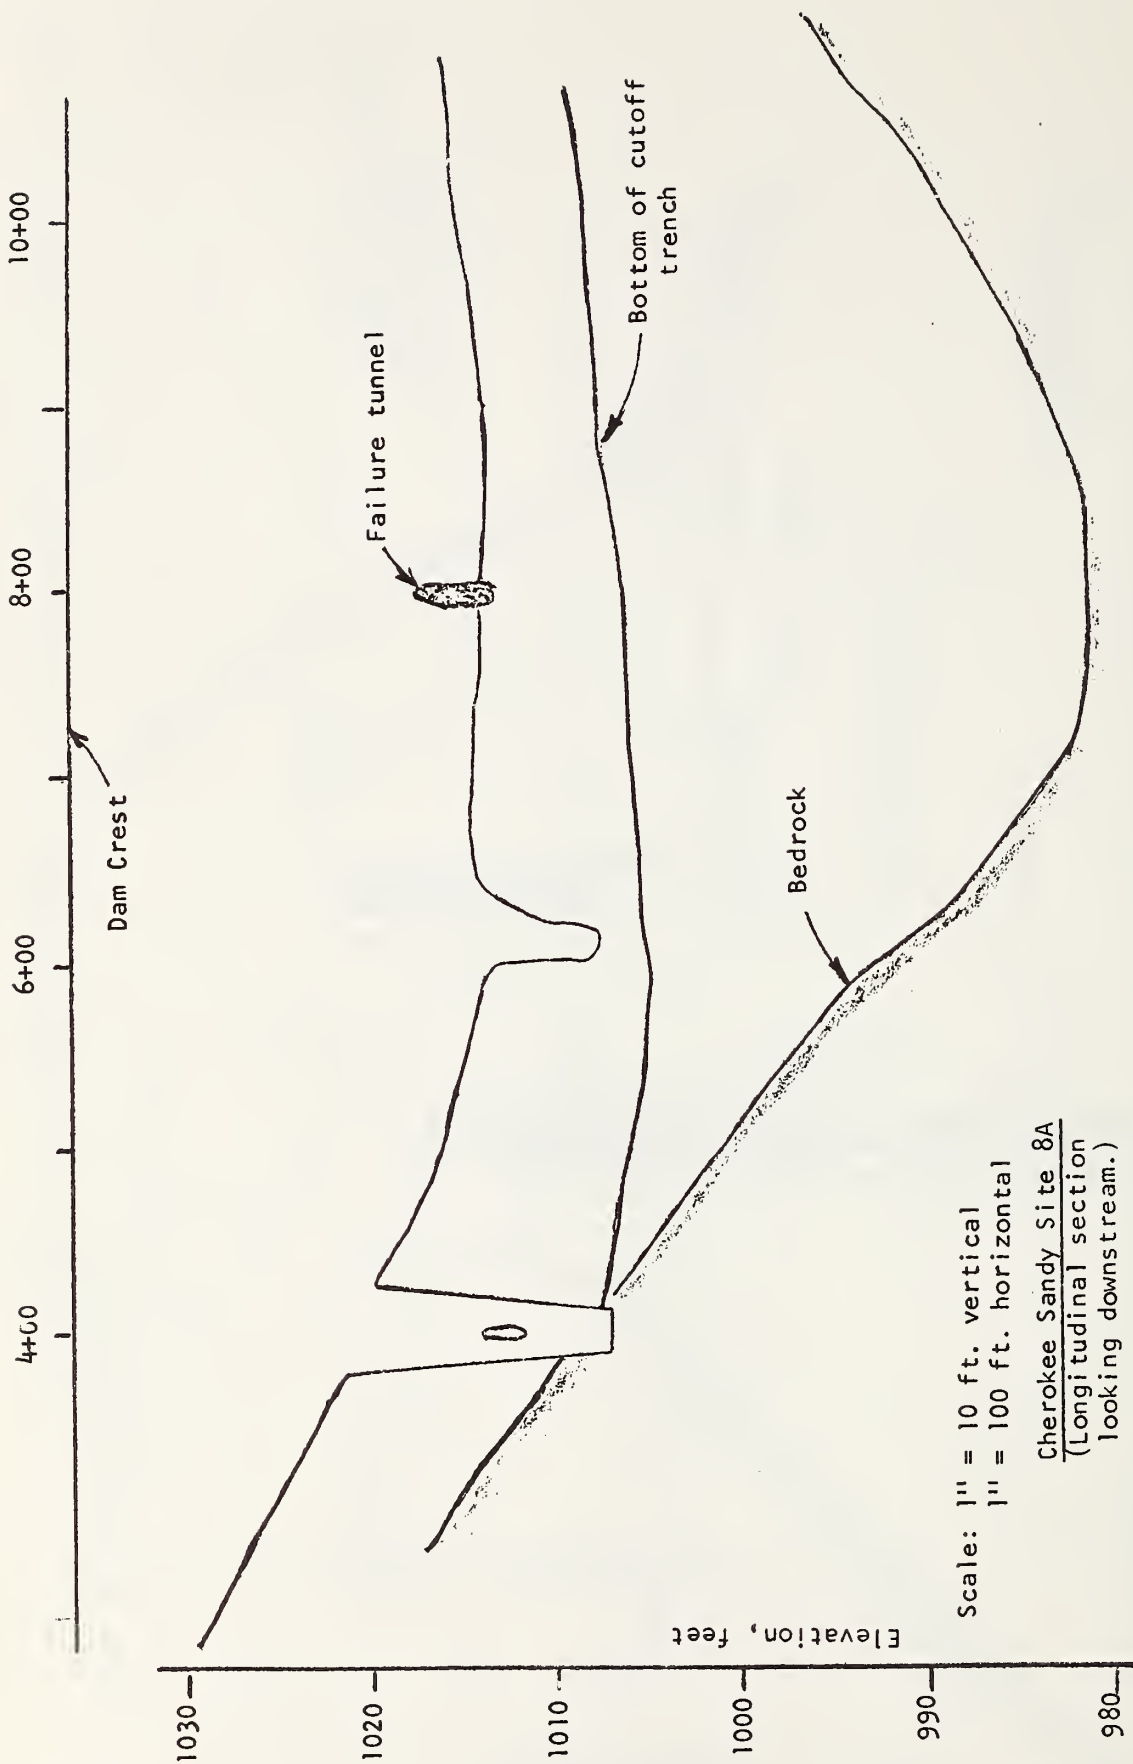
SKETCH F-4

1. With the single exception of Cherokee Sandy Creek Site 8-A (Sketch F-4) all the failures occurred where the depth to bedrock in the foundation was not great and was changing relatively rapidly. Hence, with the single exception, failures occurred at a point where relatively high differential foundation settlement would be expected.

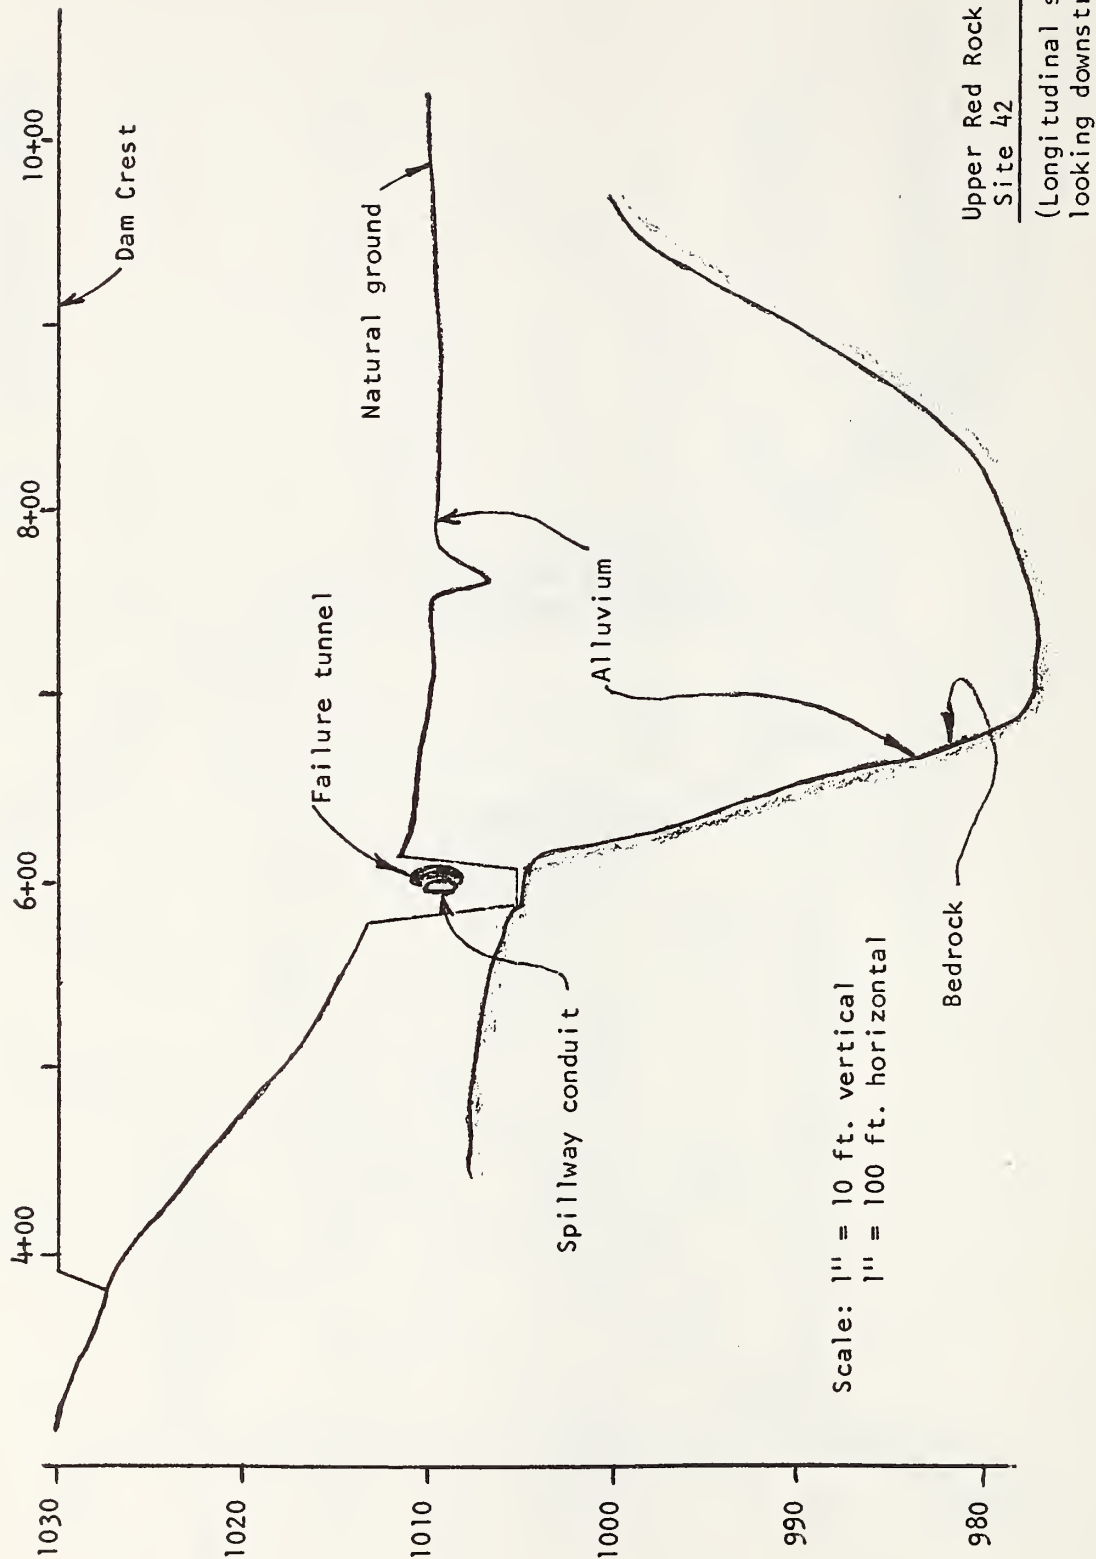
SKETCH F-8

4. In four of the dams where the conduit was exposed by the failure the conduit was underlain by several feet of compacted earth fill placed in a trench excavated under the conduit, which trench was bottomed at or near the bedrock surface, creating a condition of potential differential settlement through the dam in the vicinity of the conduit (Sketches F-1, F-5, F-6 and F-8).

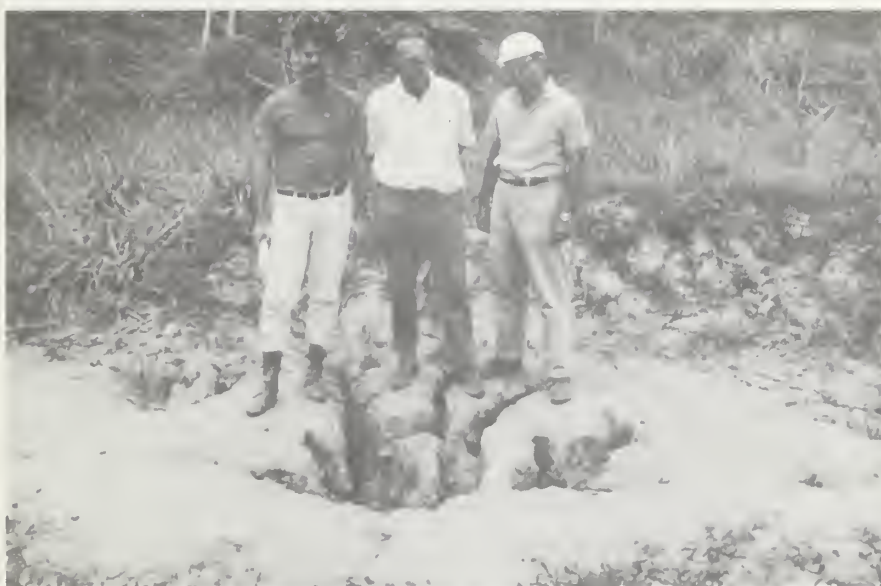
VENEZUELA FLOOD CONTROL DIKE

Photo 2: Typical view of vertical tunnel from rainfall erosion in dike crest in badly damaged zone.

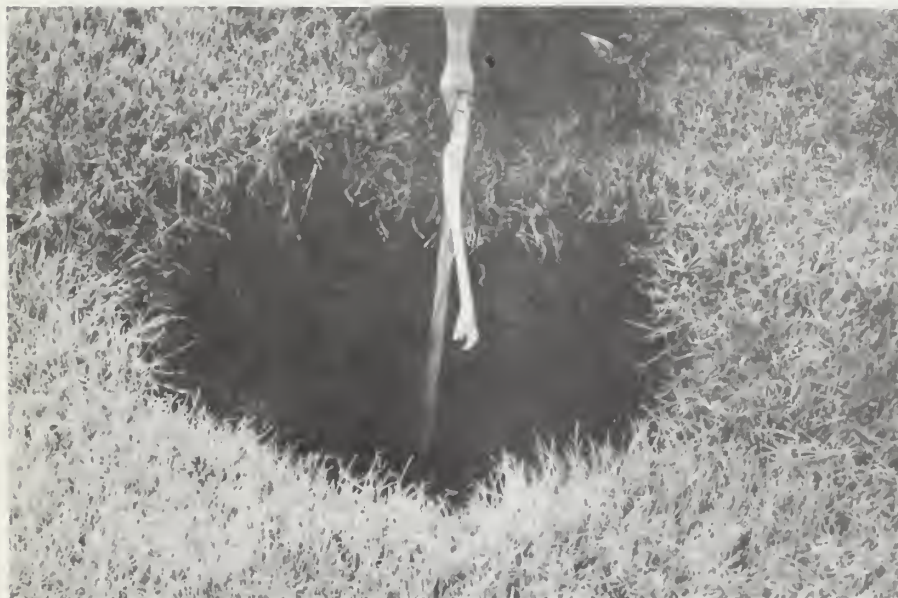
Photo 6: Grenada Dam, Miss. Showing typical erosion tunnel on downstream slope. About 24 in. diameter. Protective grass cover is mowed several times per year and is in excellent condition.

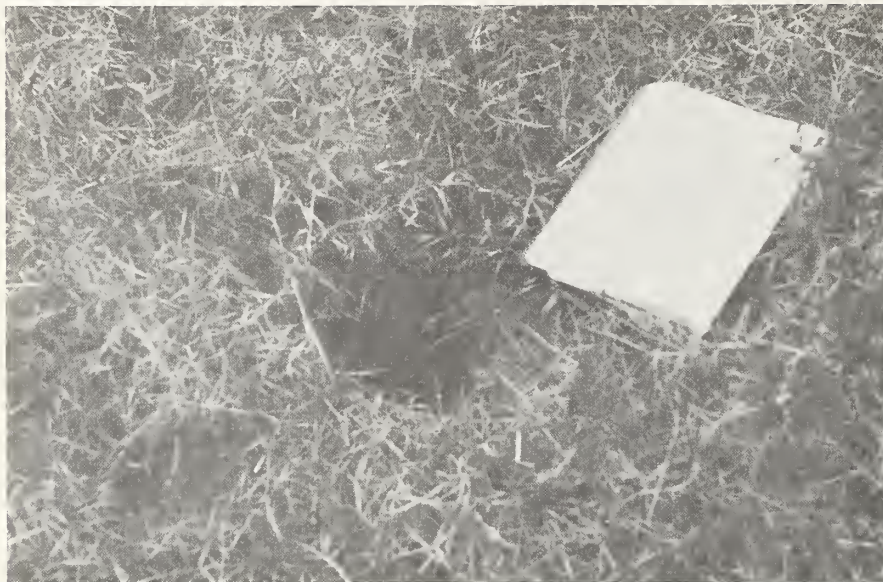
Photo 7

Erosion tunnel, 12 in. diameter, on crest of Leader Middle Boggy Creek Site 29 in spite of excellent grass protection.

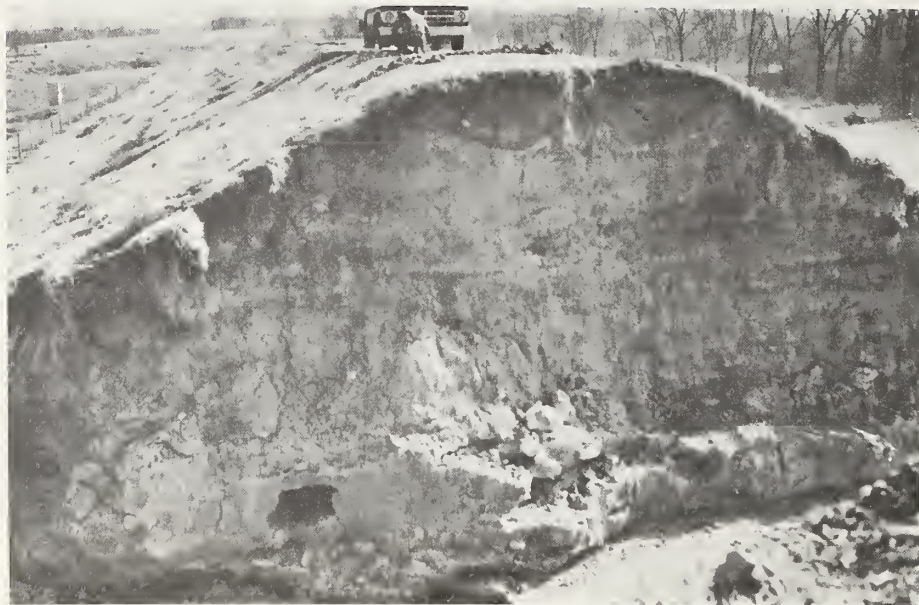
Photo 15

Left wall of failure breach. Note 24-inch diameter erosion tunnel.

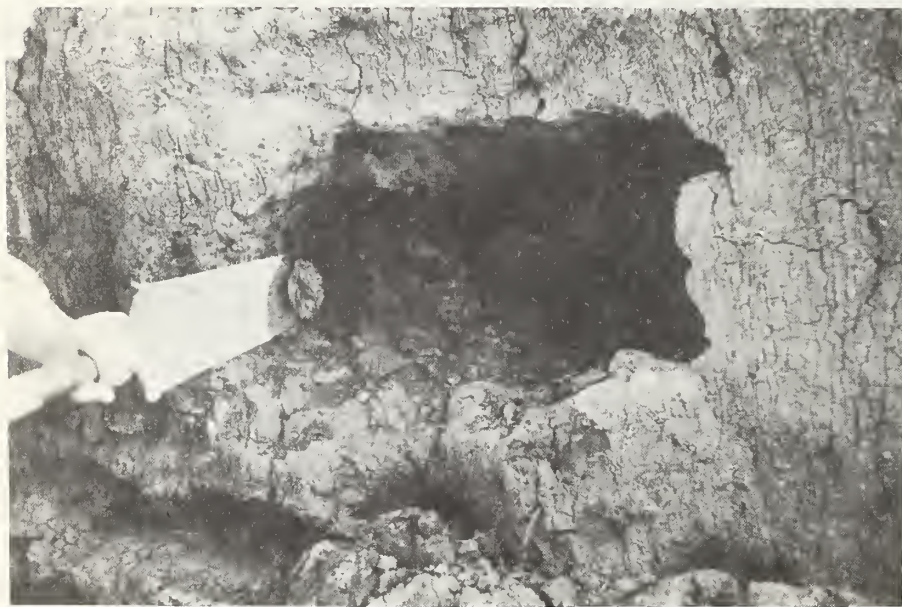
Photo 16

Erosion tunnel in left wall of breach shown above.

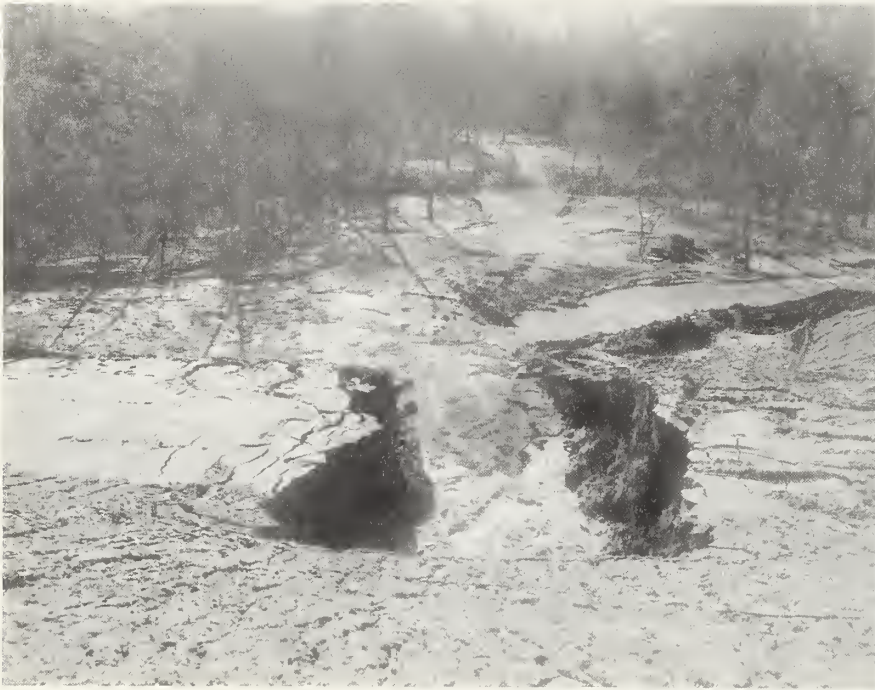
Photo 19

Caney Coon Creek Site 2 Dam, Oklahoma. Main erosion tunnel at the right abutment 24 hours after the first small leak was observed.

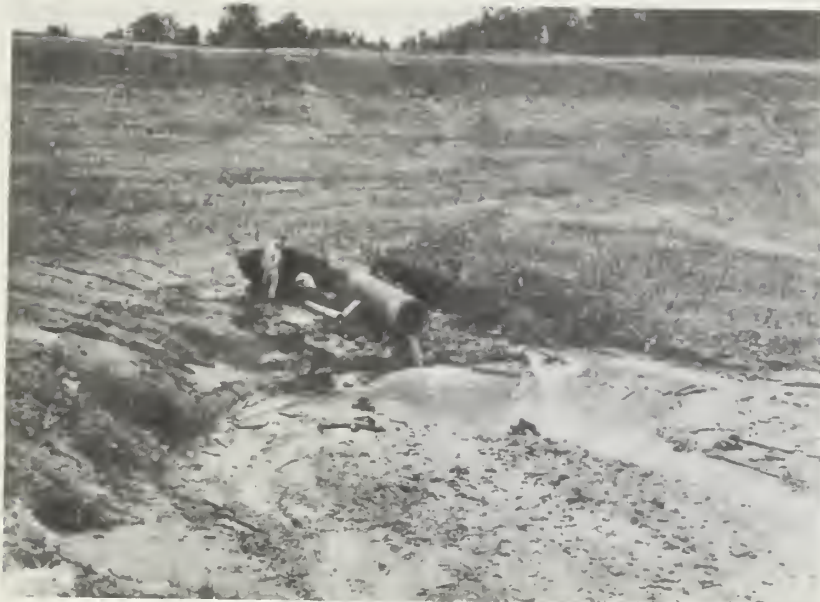
Photo 21

Downstream slope showing piping tunnels emerging on both sides of concrete pipe spillway conduit.

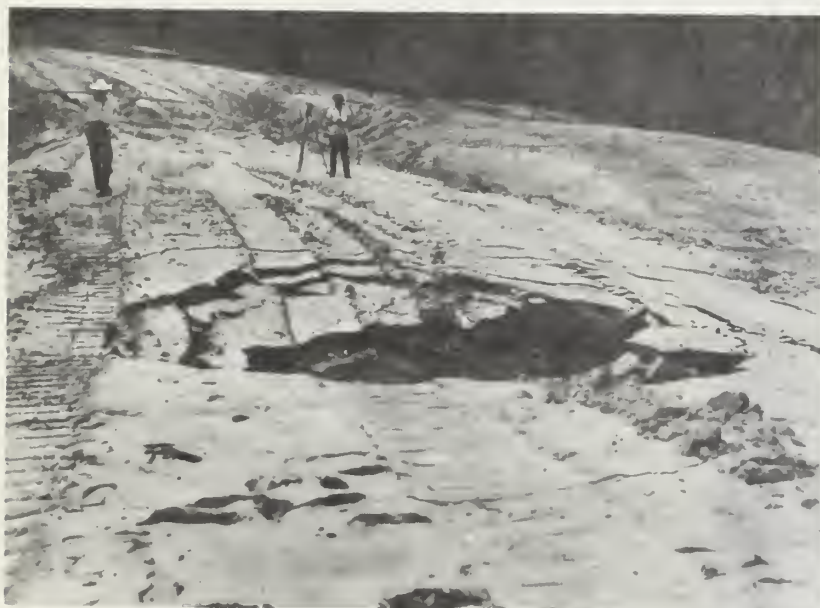
Photo 22

Collapse of roof of piping tunnel causes sinkhole on construction surface.

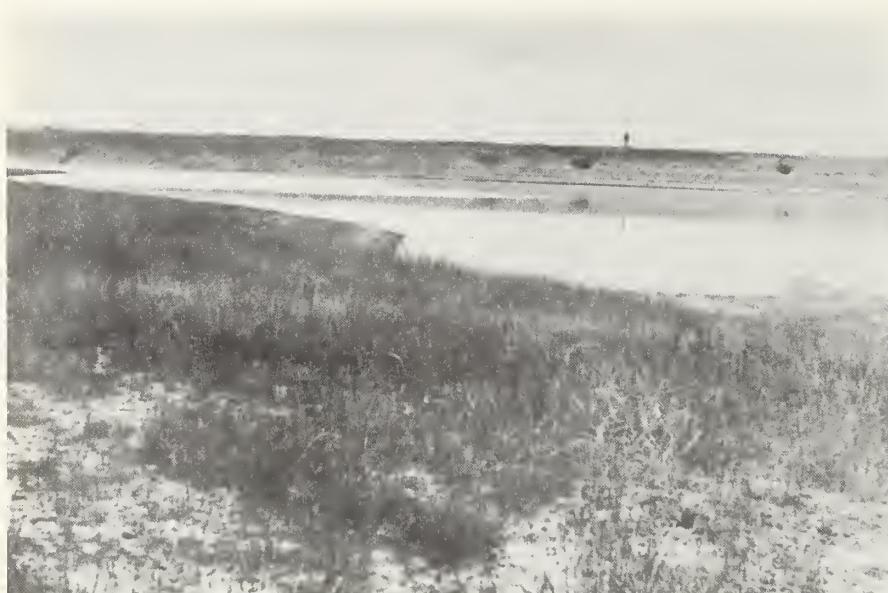
Photo 23

Upstream face of small dam in Australia showing simultaneous development of three independent piping tunnels in dispersive clay dam at about the same elevation in the embankment. (O. G. Ingles photo)

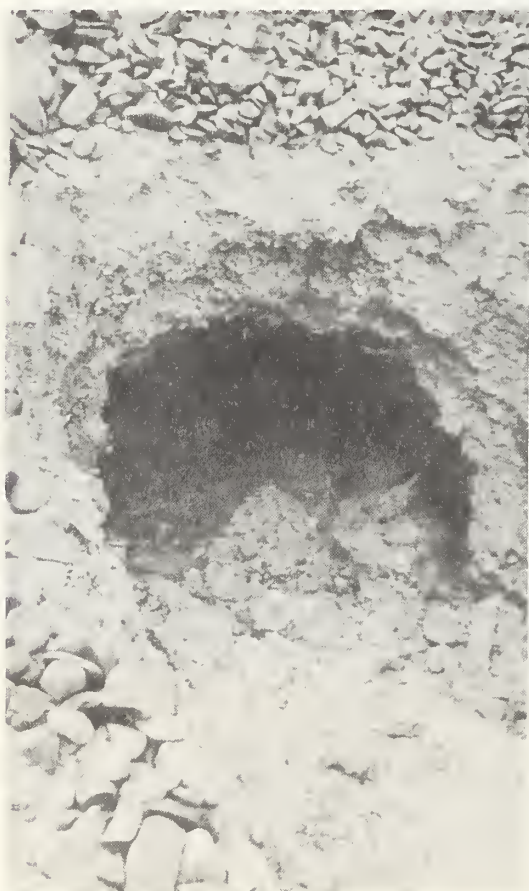
Photo 24

Entrance of piping tunnel in well constructed clay dam (Morwell Dam). The initial leak believed to have developed in a drying crack at a level where the construction work was suspended 3 months during dry weather (see Appendix A).
